First aid:proposaland proof of emergency Earthquake-resistant einforcement method for wooden building with PP band(Cabletie for baggage)

Team Project Coordinator(s): Tadashi Saito Team Members: Yoshiro Namba, Masakazu Terai, Hidenori Izumi, Koji Mabuchi

Team Code: B4H-DC2107

Project Location: Kumamoto Prefecture, Japan

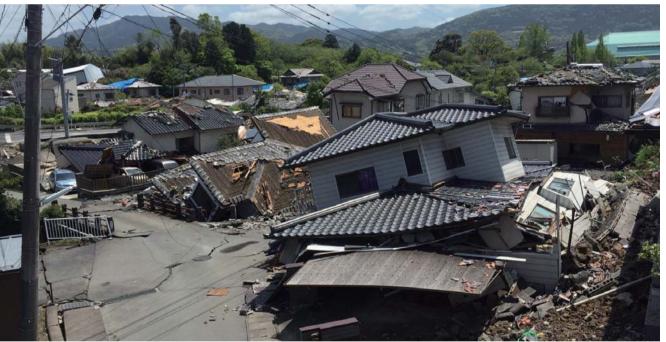
Picture 1: Damage caused by the earthquake

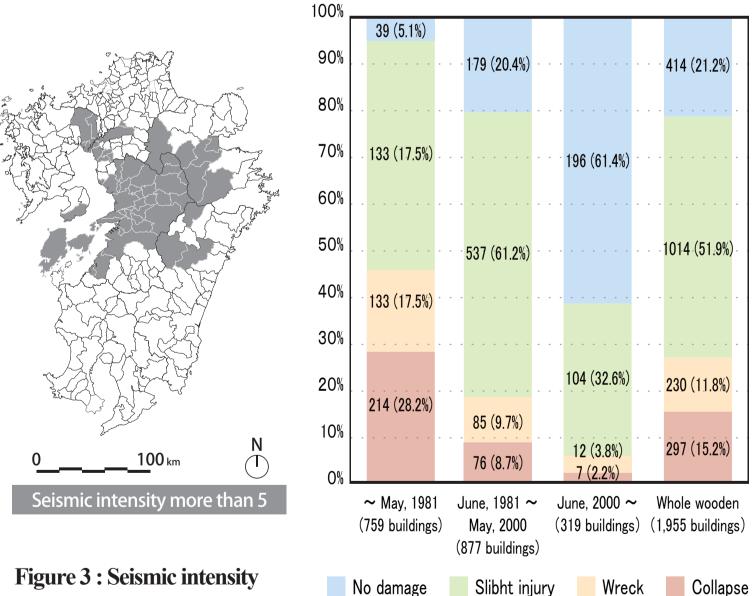
As Figure 3 show, there are many buildings that require emergency reinforcement, and the area is wide in the Kumamoto Earthquake. If strong aftershocks occur in these areas, wooden framework will loosen and there is a possibility that it will lead to secondary disasters. The problem is that responses corresponding to each determination are not taken after the emergency risk determination.

Figure 3 : Seismic intensity distribution of the Kumamoto earthquake

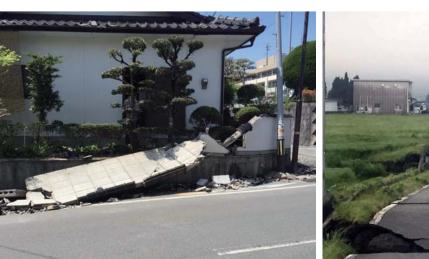
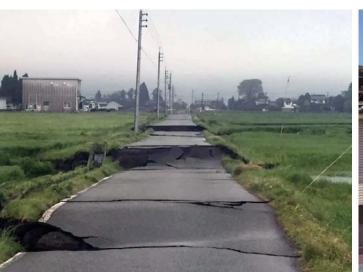
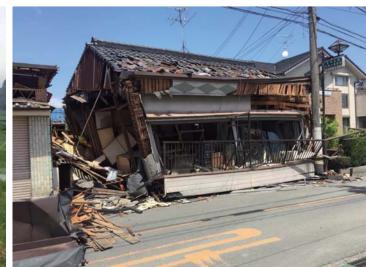
Picture 2,3,4,5 : Damage of the Kumamoto earthquake

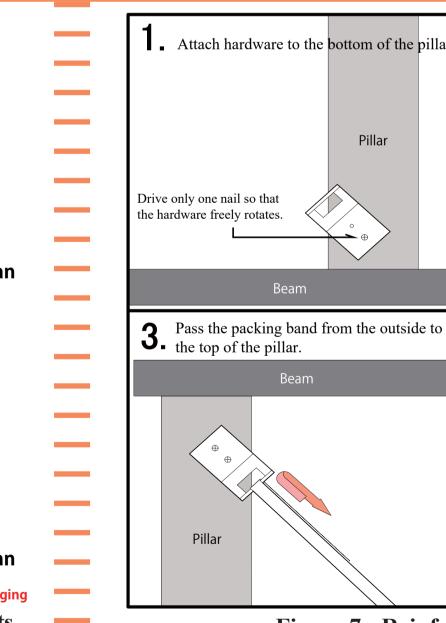
Figure 7: Reinforcement procedure

Emergency reinforcement by the packing band can be constructed from two persons. The procedure of the operation is as shown in Figure 7. The construction procedure has been simplified so that even general people can work.

- Prepare two spot seals and connect them with cellophane tape in
- Secure the mounting hardware with screws (which may be nailed) near to the column beam joint part and the column base joint part.
- Secure the packing band with one spot seal.
- Secure one side of the packing band by spot seal, the other side is passed through ametal fitting on the diagonal side, and fixed by passing through the other side of spot seal. It is generally difficult to tighten a tensile force of 100 kg or more with a person's hand. However, by using the principle of the moving pulley, a strong tensile force can be exerted.

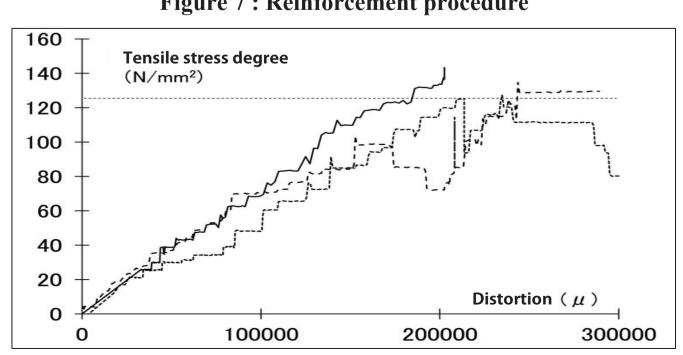
In order to confirm the tensile strength per one packing band, a tensile test was conducted. Figure 8 shows the relationship between the tensile stress and the strain of three packaging bands. The packaging band starts to tear partially from the tensile stress degree of about 30 N/mm². It has been confirmed that it withstand up to about 125 N / mm² after starting to split.

Figure 8: Tensile test results
